**CARBON COUNTY AML STATEWIDE MAINTENANCE
PALMER PROJECT
CARBON COUNTY, MONTANA**

DECEMBER 30, 1989

SPECTRUM ENGINEERING

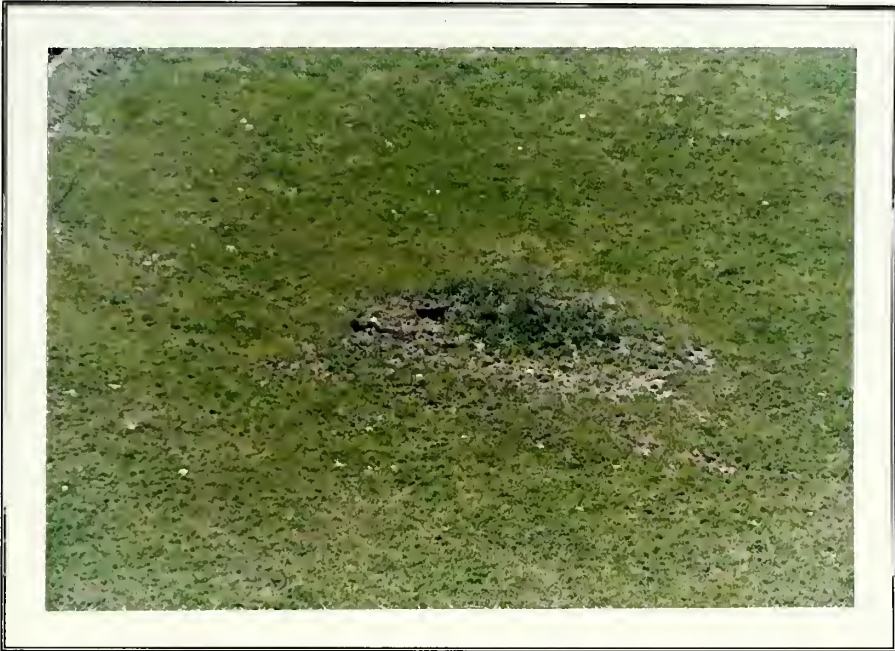
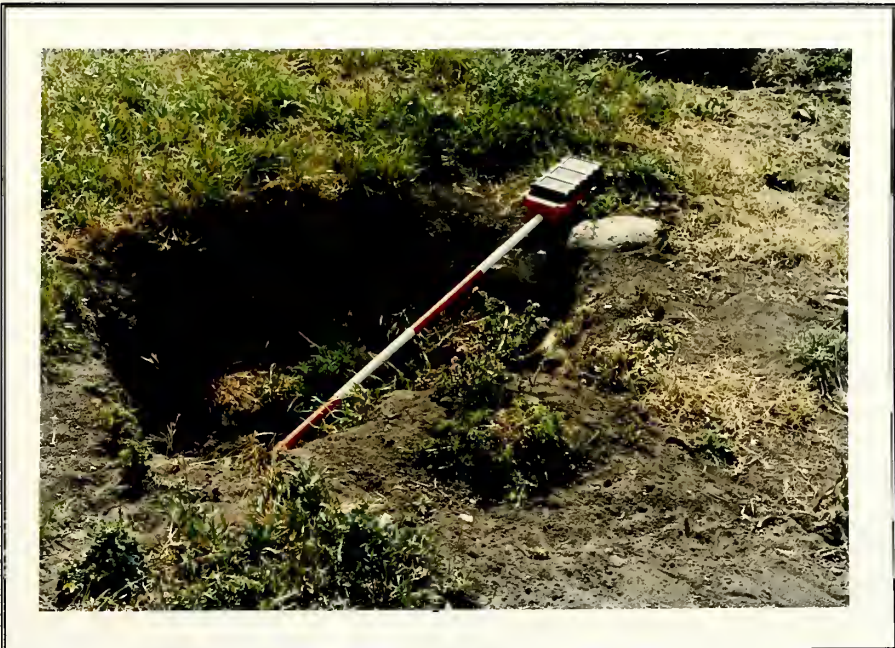
Hayfield Subsidence Depression 1 (Photos 1 & 2) is generally elliptical in shape measuring 60 feet long by 25 feet wide. Located within the north portion of the depression is a 4 feet by 5 feet hole having a depth of 2 feet. Subsidence depth (excluding the hole) is about 6 inches. Some hay crop vegetation has been established within the depression, but the density is sparse. Total affected area is approximately 0.03 acre.

PHOTO 1 - Hayfield Subsidence Depression 1: Aerial view.

PHOTO 2 - Hayfield Subsidence Depression 1: Close up.

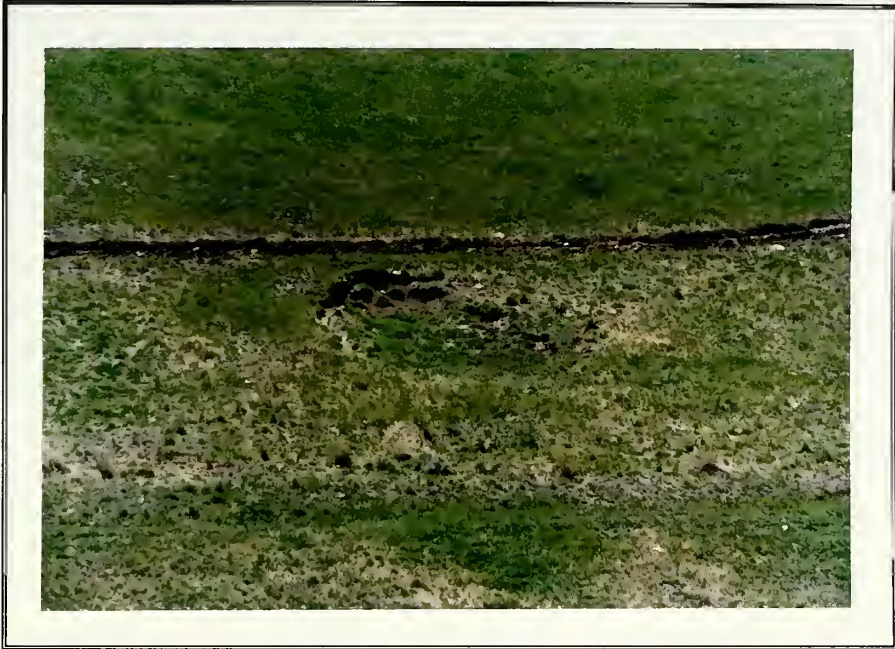
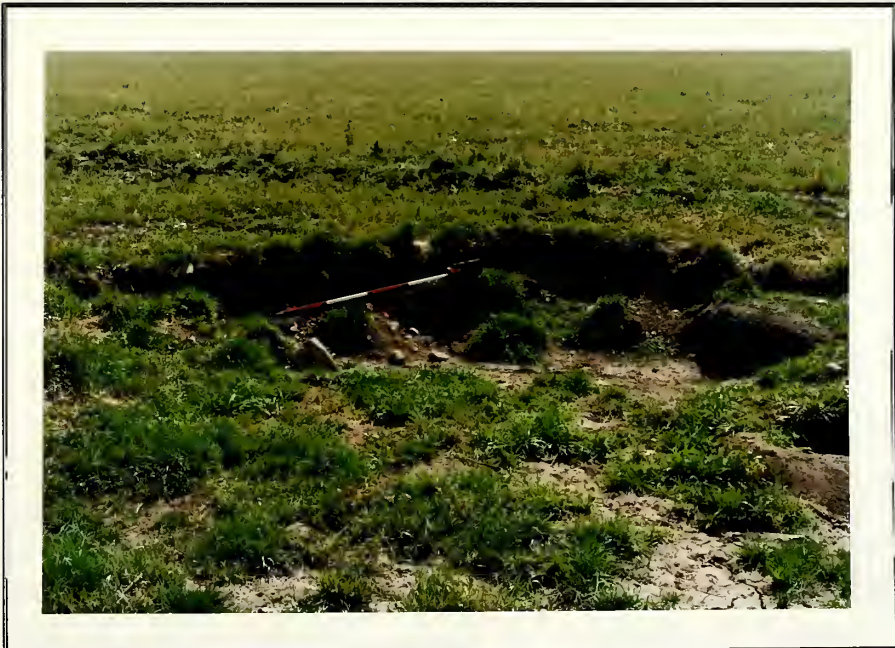
Hayfield Subsidence Depression 2 (Photos 3 & 4) is nearly circular in shape measuring 36 to 40 feet in diameter. Maximum subsidence depth is 20 inches and averages about 12 inches. Sparse hay crop vegetation has been established within the depression. Total affected area is approximately 0.03 acre.

PHOTO 3 - Hayfield Subsidence Depression 2: Aerial view.

PHOTO 4 - Hayfield Subsidence Depression 2: Close up.

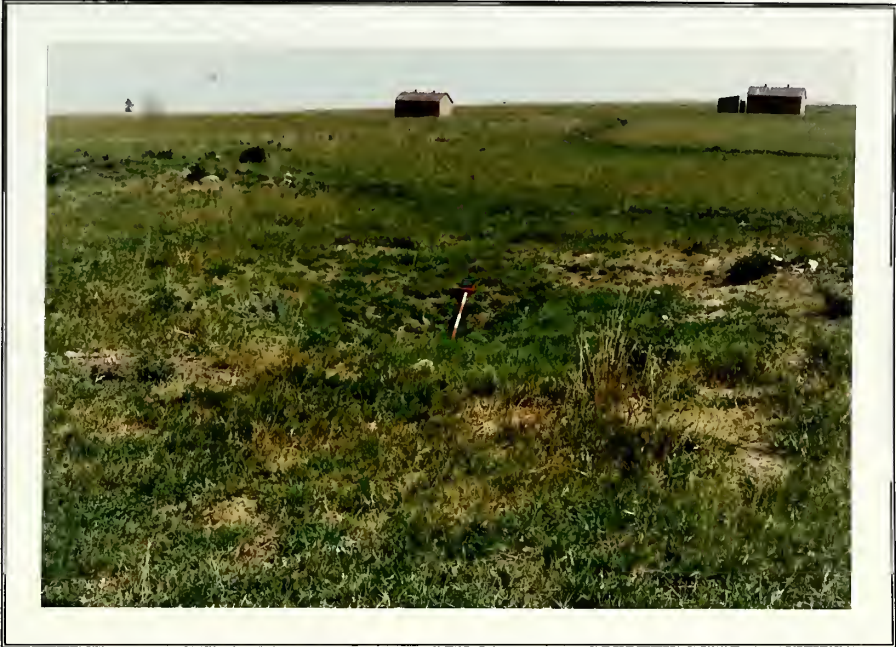
Hayfield Subsidence Depression 3 (Photo 5) is a circular depression approximately 30 feet in diameter exhibiting minor subsidence with a maximum depth of 18 inches. Sparse hay crop vegetation has been established within the depression. Total affected area is approximately 0.02 acres.

PHOTO 5 - Hayfield Subsidence Depression 3.

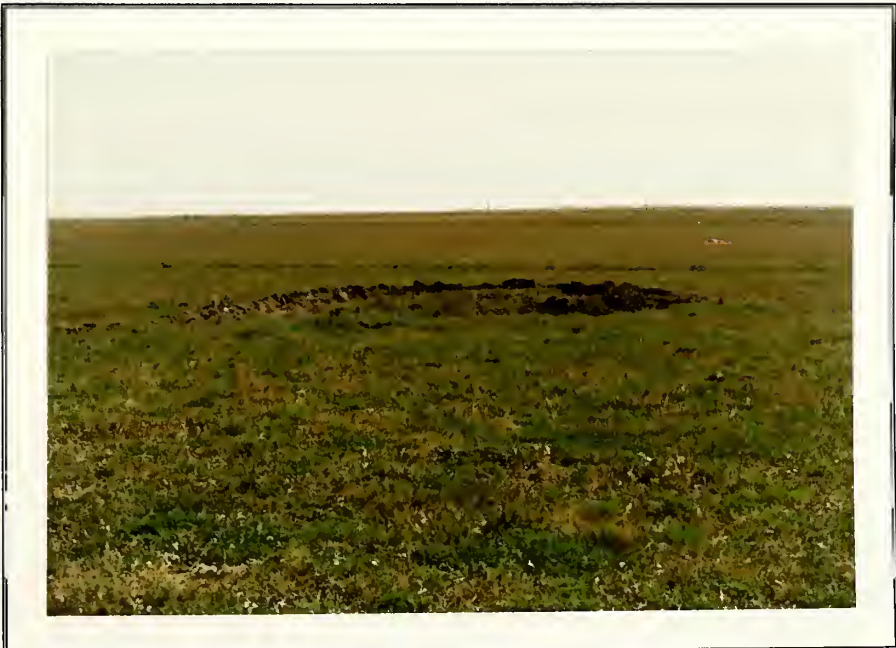
North of Hayfield Subsidence Depression 3 there is a possible mine related disturbance (see Photo 6). However, no subsidence was identified and the area poses no danger. No action was recommended for this area.

PHOTO 6 - Possible mine related disturbance: No Action.

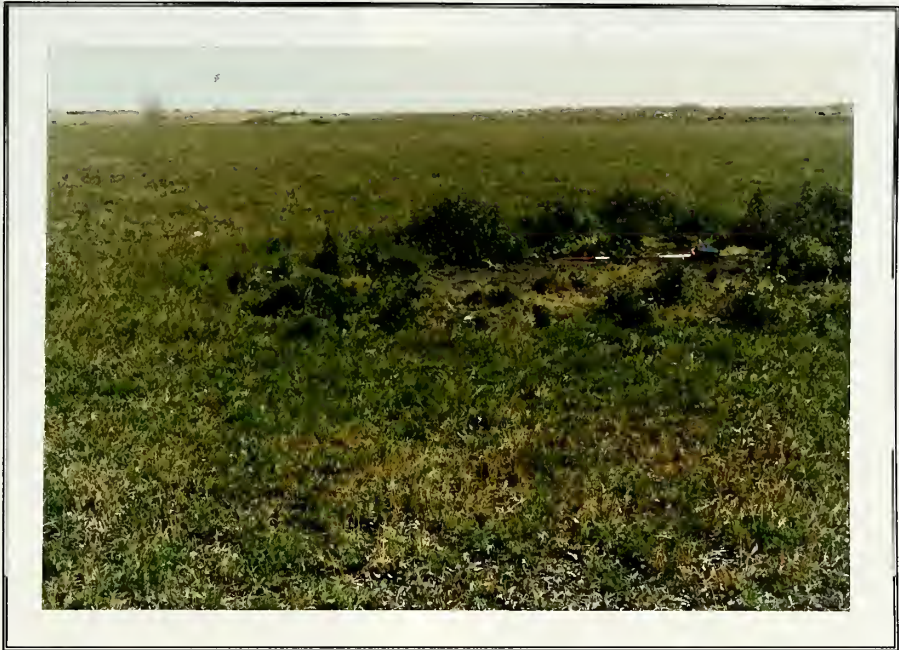
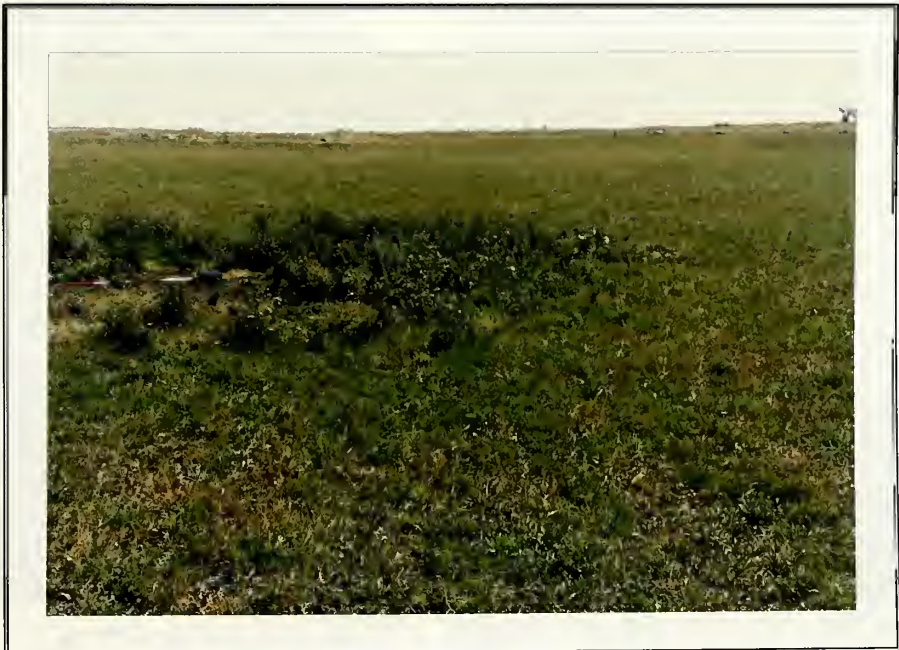
Hayfield Subsidence Depression 4 (Photos 7 & 8) is a circular area approximately 35 feet in diameter. No subsidence was noted. However, the area appears to have contained coal slack in the past. It is thought that the coal slack was disposed of during previous AML reclamation. The area is sparsely overgrown with thistles and other weeds. Total affected area is approximately 0.02 acres.

PHOTO 7 - Hayfield Subsidence Depression 4: Photo 1 of 2.

PHOTO 8 - Hayfield Subsidence Depression 4: Photo 2 of 2.

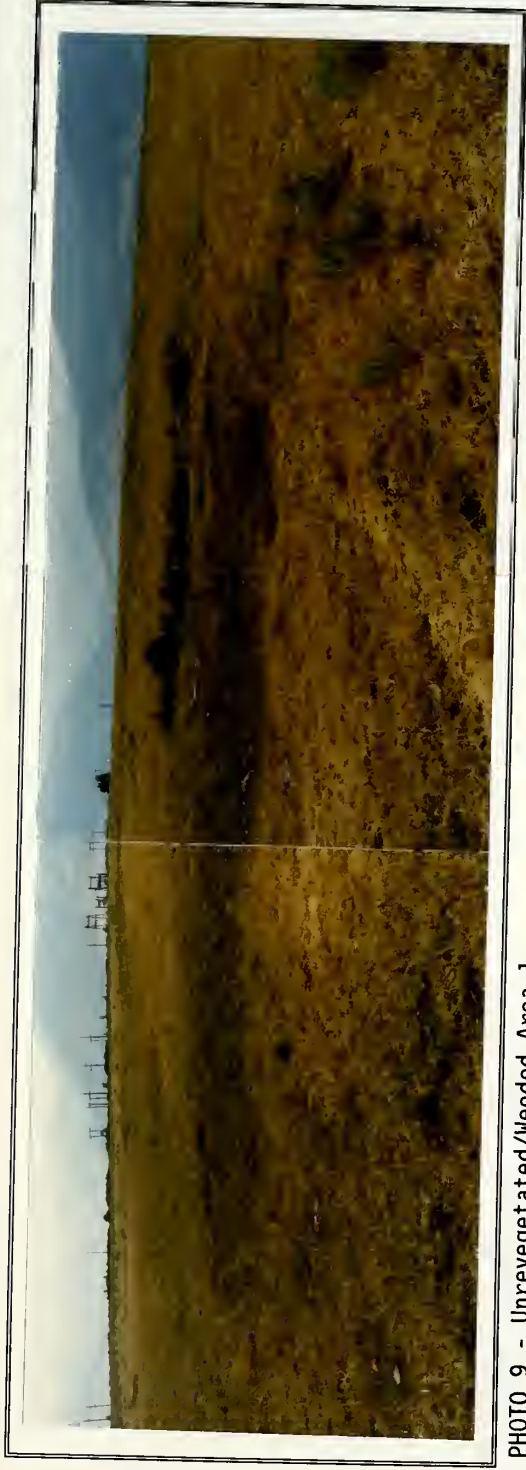
Unrevegetated/Weeded Area 1 (Photo 9) is an elliptical shaped area approximately 80 feet long by 44 feet wide. It is thought that this is a previously backfilled subsidence depression. Total affected area is approximately 0.07 acre.

PHOTO 9 - Unrevegetated/Weeded Area 1.

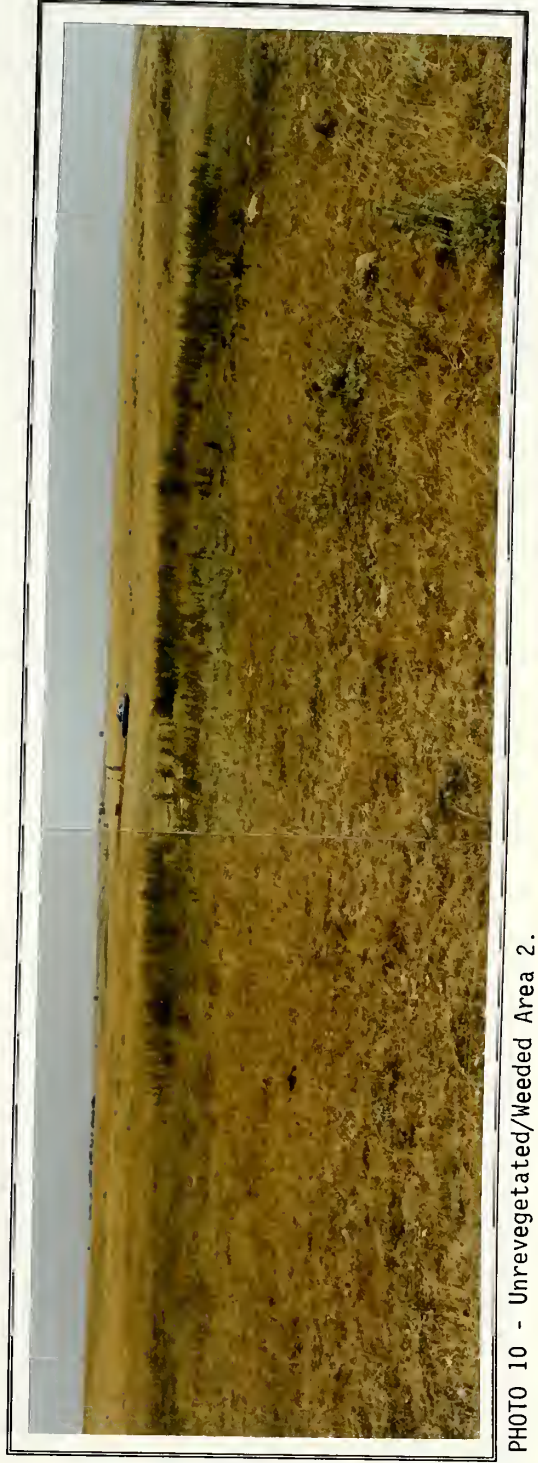
Unrevegetated/Weeded Area 2 (Photo 10) is an elliptical shaped area approximately 110 feet long by 65 feet wide. It is thought that this is a previously backfilled subsidence depression. Total affected area is approximately 0.14 acre.

PHOTO 10 - Unrevegetated/Weeded Area 2.

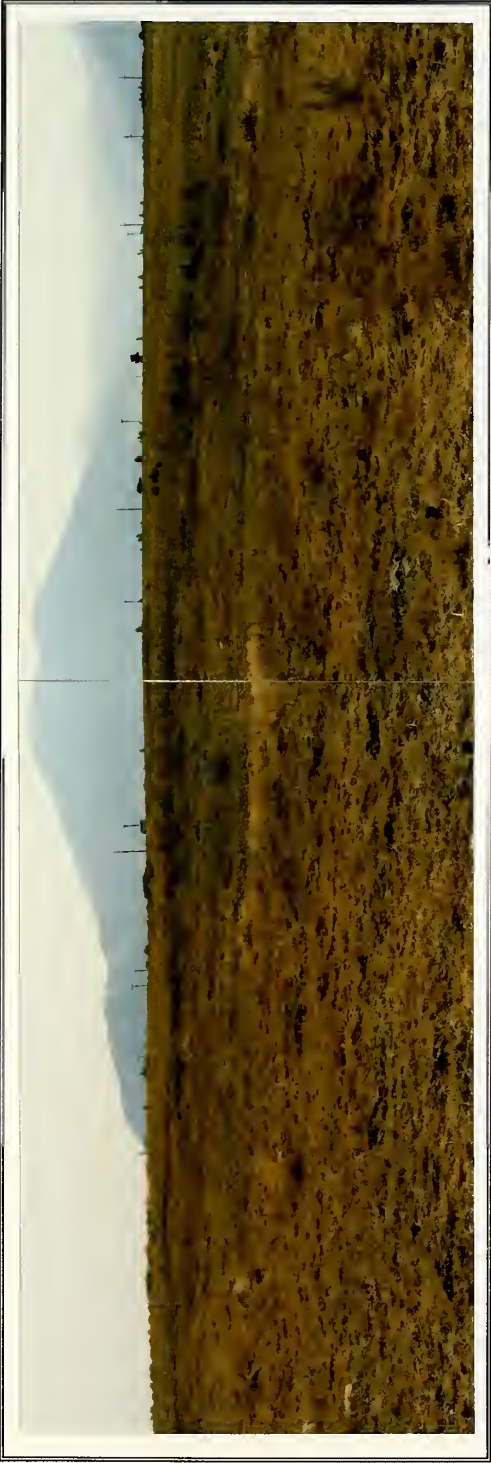
Unrevegetated/Weeded Area 3 (Photo 11) is an elliptical shaped area approximately 126 feet long by 78 feet wide. It is thought that this is a previously backfilled subsidence depression. Total affected area is approximately 0.19 acre.

PHOTO 11 - Unrevegetated/Weeded Area 3.

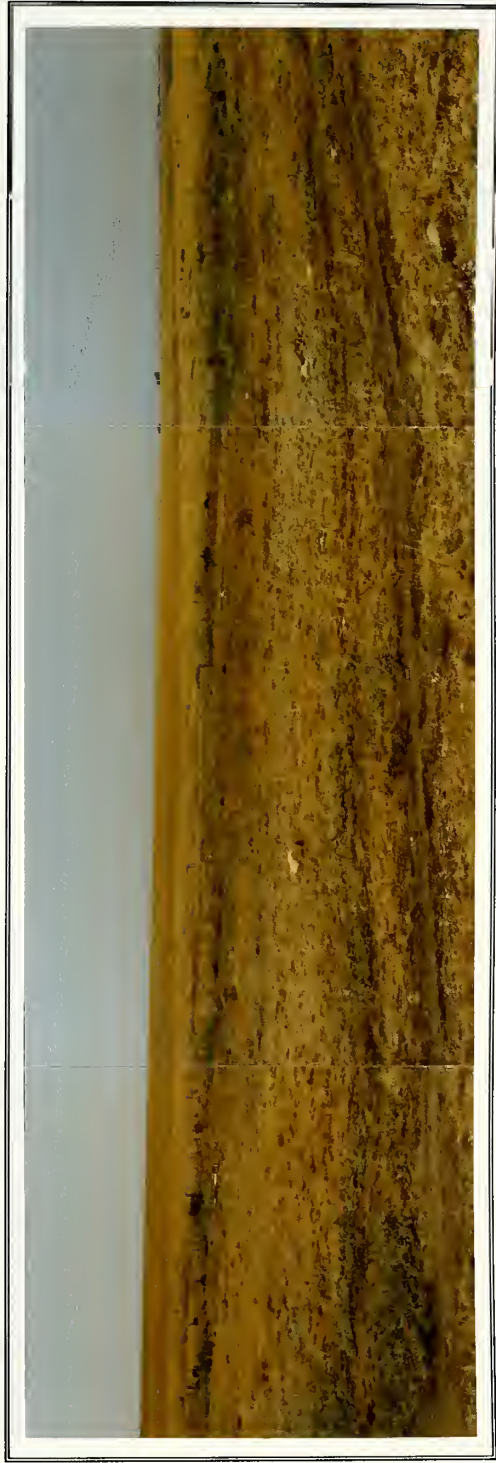
Unrevegetated/Weeded Area 5 (Photo 12) is a rectangular shaped area approximately 225 feet long by 75 feet wide. It is thought that this is a previous borrow area. Total affected area is approximately 0.32 acre.

PHOTO 12 - Unrevegetated/Weeded Area 5.

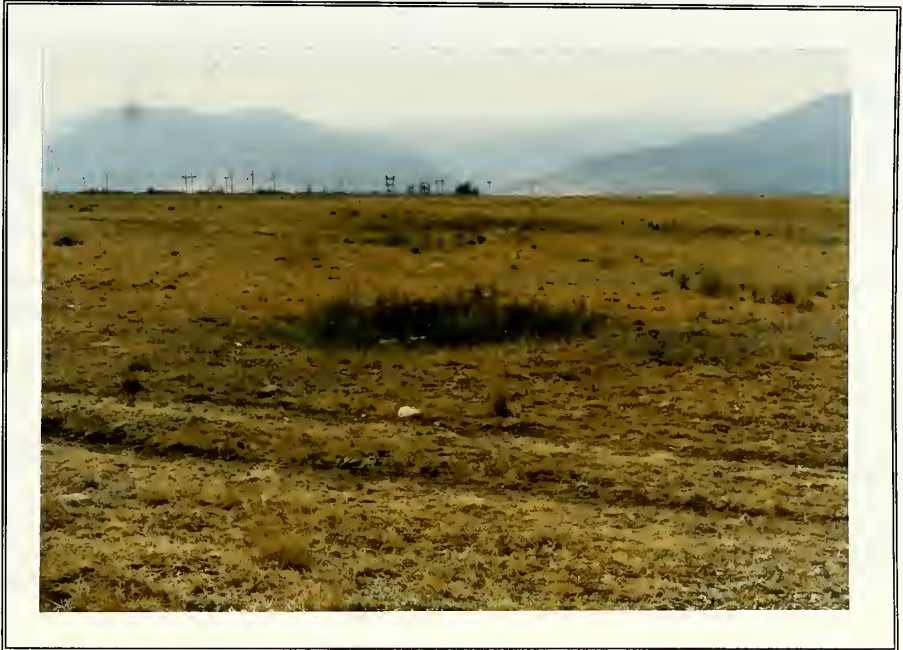
Unrevegetated/Weeded Area 4 (Photo 13) is a circular shaped area approximately 17 feet in diameter. It is thought that this is a previously backfilled subsidence depression. Total affected area is less than 0.01 acre.

PHOTO 13 - Unrevegetated/Weeded Area 4.

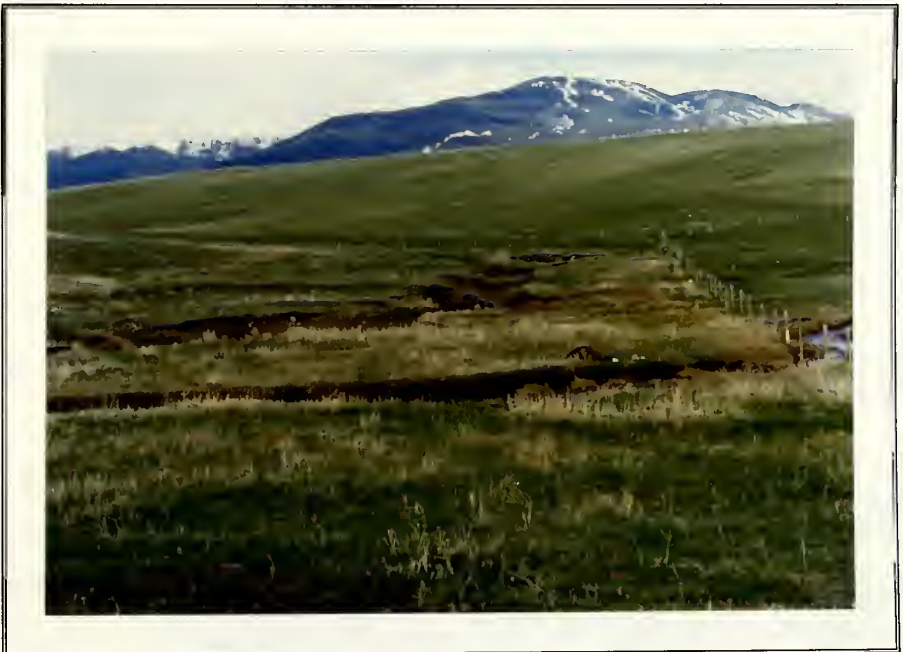
Clear Creek Subsidence Area (Photo 14) consists of several connecting subsidence depressions affecting a rectangular area approximately 450 feet long by 100 feet wide. The west end of the depressions intercepts the water course of a spring at the head of the Clear Creek drainage. The spring water runs into the subsidence depressions and flows eastward along the entire length of the depressions where the water then vanishes into the ground. The subsidence depressions appear to be relatively stable; however, it is expected that additional subsidence may occur in the future. The depth of the depressions range from 5 feet to a maximum of 10 feet.

PHOTO 14 - Clear Creek Subsidence Area. (SLIDE 1)

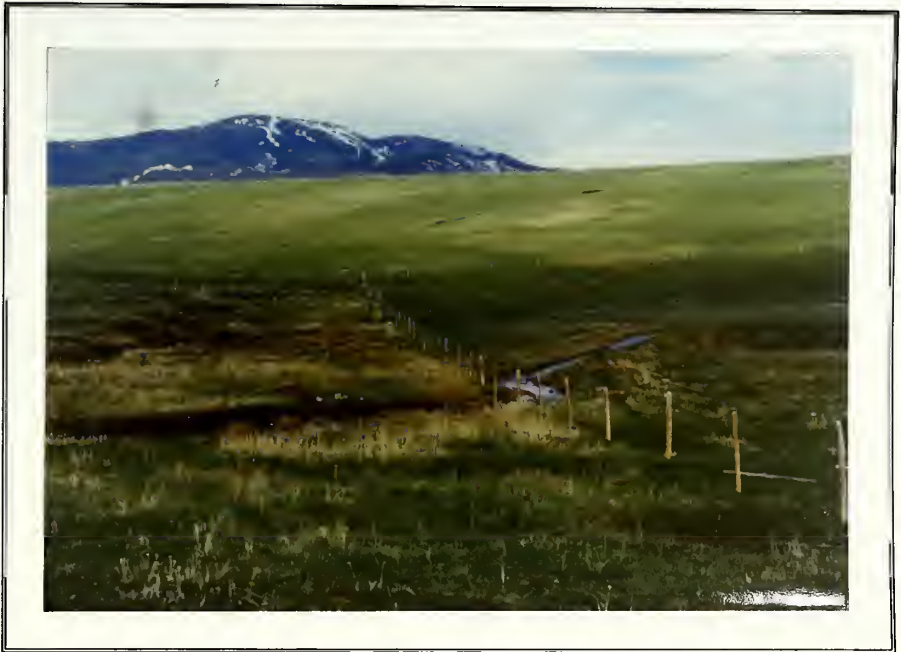
SLIDE 2 - Clear Creek Subsidence Area (looking west).

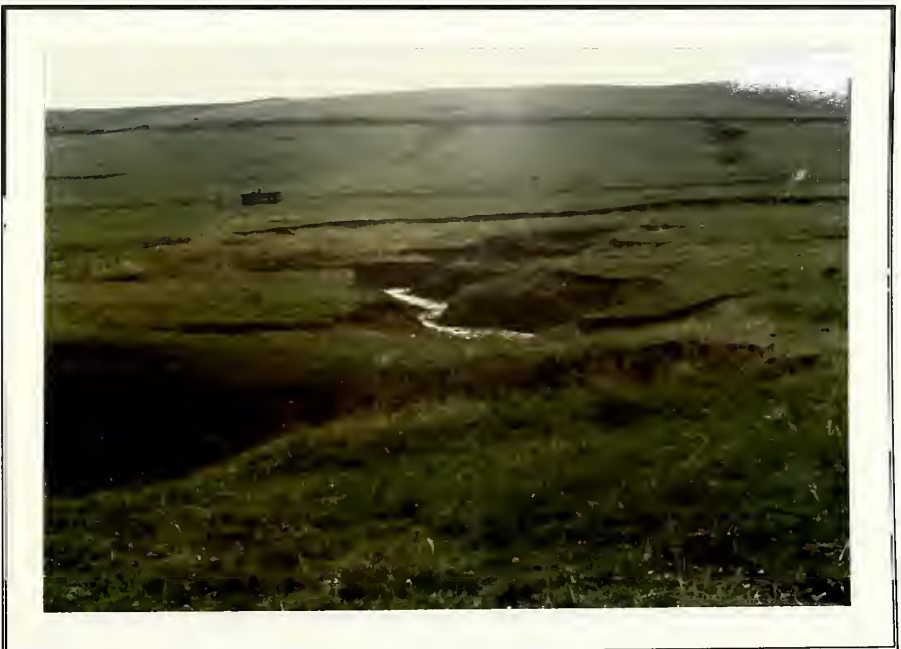
SLIDE 3 - Clear Creek Subsidence Area (looking east).
